Dent EstimatorsTM Process Flow

Dent Estimators Estimation System Specifications

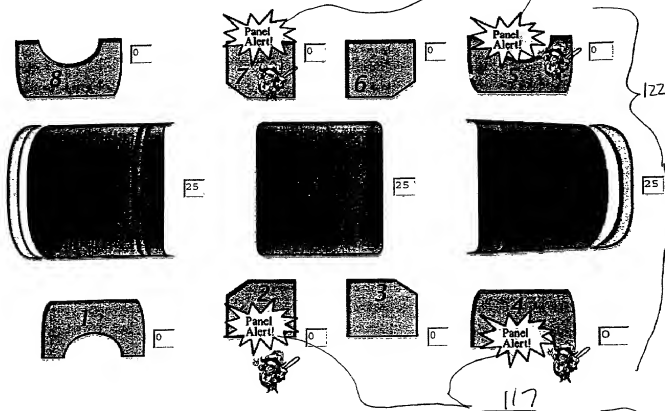
FIG. 16A

Indicate the dent sizes by clicking on the appropriate size. If multiple sizes are observed, be sure to check all that apply.

Enter the number of dents for each panel that has damage.

Parts to be included in the estimate.

Indicate any additional considerations that should be included in the estimate.

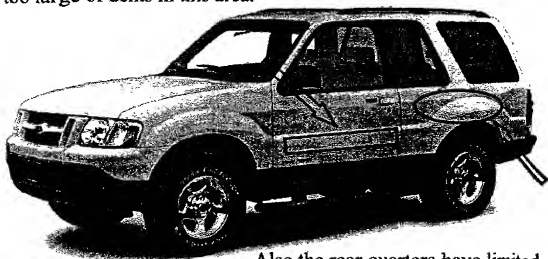
FIG. 21

There is extremely tight bracing in the front doors, be aware not to estimate too large of dents in this area.

Also the rear quarters have limited access. Smaller hail dents are O.K. in this area.
